**Energy Company Saves \$6M USD with
a Performance Engineering Digital Twin**

Fighting Frequent Unplanned Shutdowns at a Gas Plant

Troubleshooting with a Digital Twin

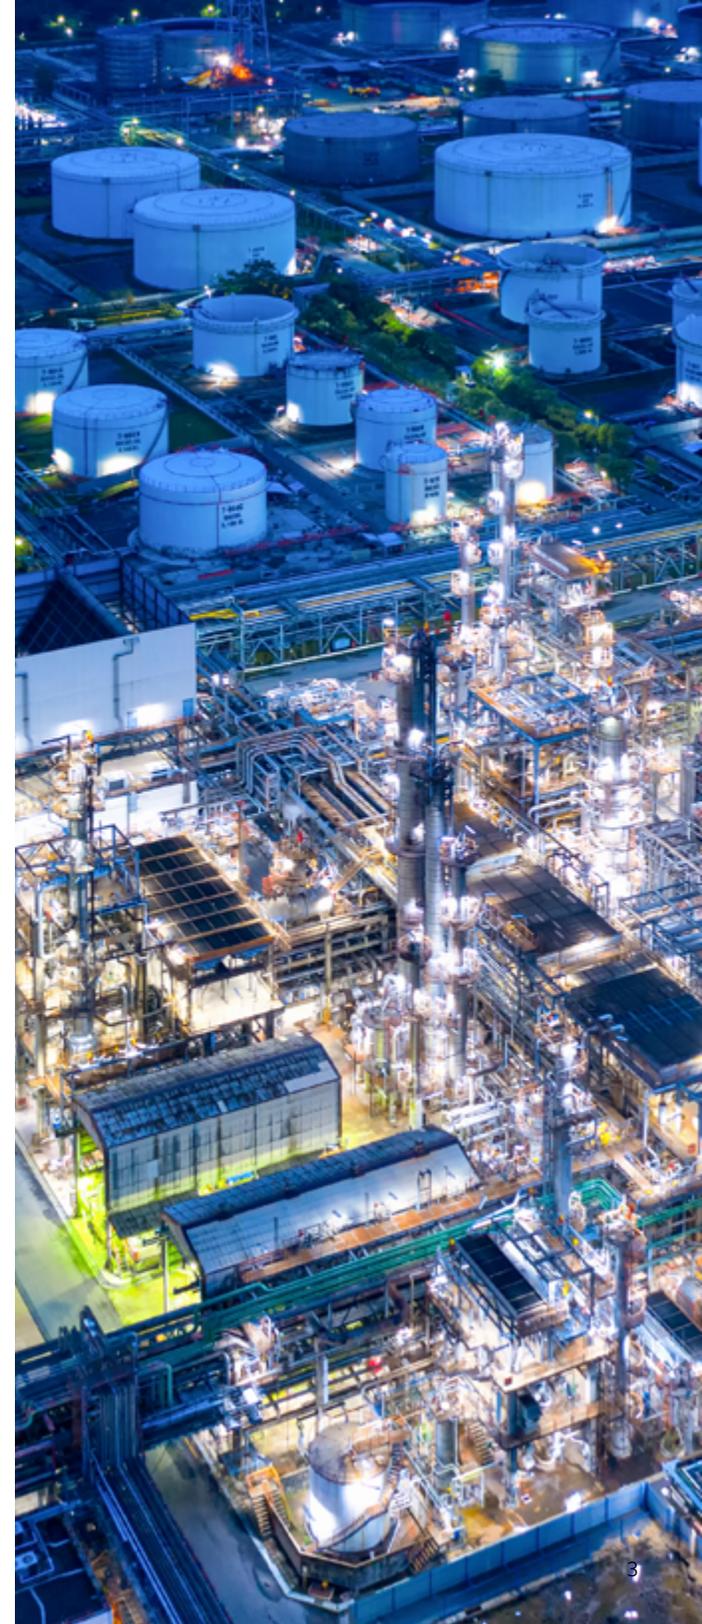
Thermosiphon Piping

Piping Reference Points	ft	Pressure Points	psi	°F	Quality
Height of liquid in column	13.7927	Liquid level in column	24.7		
Height of heat transfer region inlet	5.958	Inlet to exchanger	27.98	243.59	
Height of heat transfer region outlet	8.5622	Inlet to heated section	27.42		
Height of column return line	16.3747	Boiling boundary position	27.42		
		Outlet of heated section	24.38	243.91	0.12
		Exit of outlet piping	24.7	243.91	0.12
Pressure changes (-loss/+gain)	psi	Inlet Circuit	Exchanger	Outlet Circuit	
Frictional		-0.04	-2.54	-0.37	
Gravitational		3.32	-0.55	-0.39	
Momentum		0		0	
Flashing			-0.02		
Nozzles			-0.16		
Unaccounted		0		0.76	
Total		3.28	-3.28	0

Thermosiphon Stability Unstable — two-phase instability possible

Figure 1. Pressure losses Aspen EDR estimated before modifications

Thermosiphons / Kettles / Knockback Condenser

Thermosiphons	
Thermosiphon stability	Unstable — two-phase instability possible
Kutateladze Number in axial nozzle (should be > 3.2)	3.15
Circuit DeltaP ratio (Outlet/Inlet)	82.062
Vertical tube side thermosiphons	
Flow reversal criterion — top of the tubes (should be > 0.5)	
Flooding criterion — top of the tubes (should > 1.0)	
Fraction of tube length before boiling starts

Figure 2. Instability analysis before modifications

The models demonstrated that while the column was operating normally and far from flooding and weeping conditions, the actual problem was occurring in the thermosiphon circuit. Engineers observed that piping and sizing were causing unstable operations and a very low level of liquid at the bottom of the tower and the reboiler, generating excessive surface heating in the tubes and exposure to acid gas corrosion.

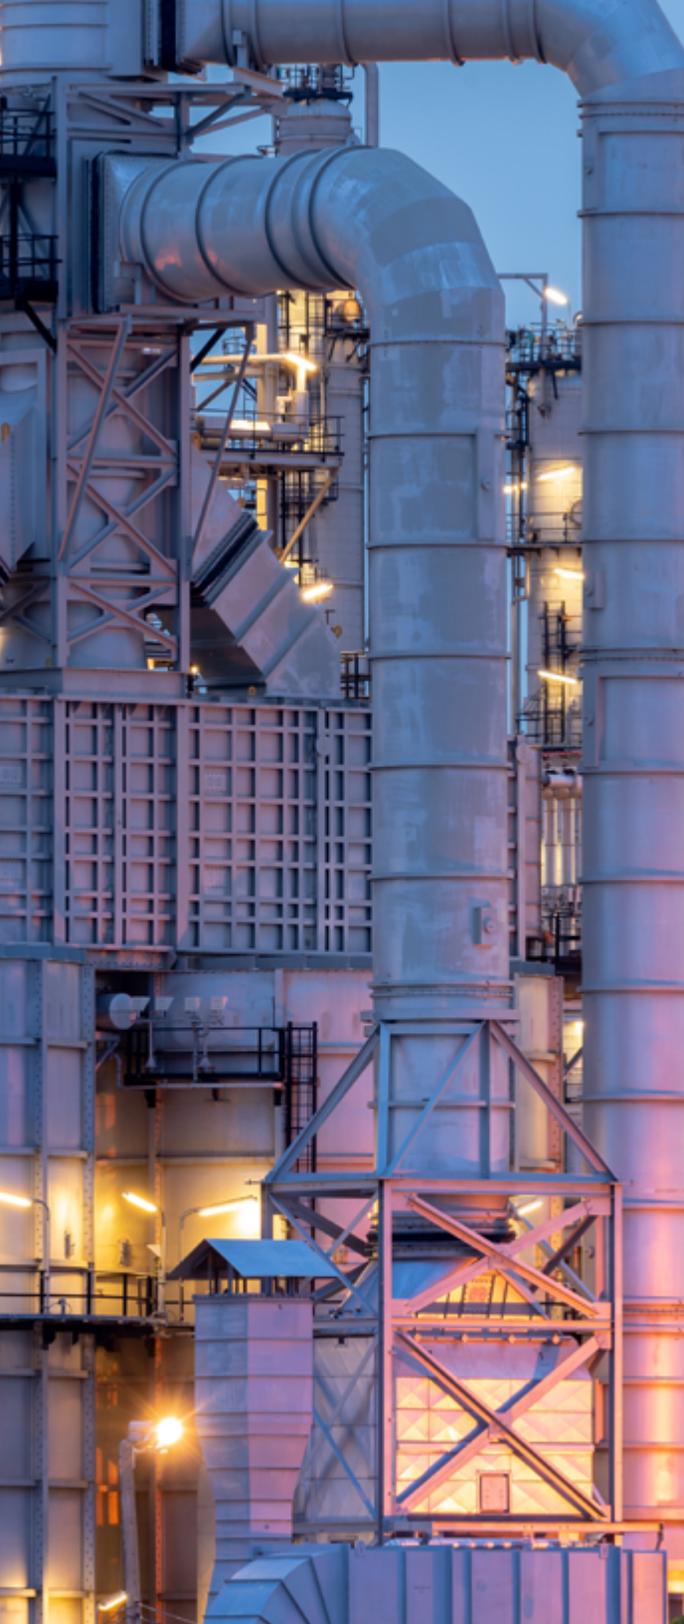
Thermosiphon Piping

Piping Reference Points	ft	Pressure Points	psi	°F	Quality
Height of liquid in column	11.8	Liquid level in column	26.7		
Height of heat transfer region inlet	5.3445	Inlet to exchanger	28.72	247.84	
Height of heat transfer region outlet	9.1778	Inlet to heated section	27.88		
Height of column return line	16.378	Boiling boundary position	27.88		
		Outlet of heated section	27.72	249.54	0.11
		Exit of outlet piping	26.7	248.37	0.11
Pressure changes (-loss/+gain)	psi	Inlet Circuit	Exchanger	Outlet Circuit	
Frictional		-0.71	-0.15	-0.51	
Gravitational		2.73	-0.82	-0.07	
Momentum		0		0	
Flashing			0		
Nozzles			-0.48		
Unaccounted		0		0.01	
Total		2.02	-1.45	-0.57

Thermosiphons Stability Stable — Circuit DeltaP ratio (Outlet/Inlet) < critical ratio of 2.

Figure 3. Pressure losses estimated by Aspen EDR after modifications

Thermosiphons / Kettles / Knockback Condenser

Thermosiphons	
Thermosiphon stability	Unstable — DeltaP ratio (Outlet/Inlet) < critical ratio of 2
Kutateladze Number in axial nozzle (should be > 3.2)	5.88
Circuit DeltaP ratio (Outlet/Inlet)	1.627
Vertical tube side thermosiphons	
Flow reversal criterion — top of the tubes (should be > 0.5)	
Flooding criterion — top of the tubes (should > 1.0)	
Fraction of tube length before boiling starts

Figure 4. Instability analysis after modifications

To correct the problem, the company decided to change pipe diameters and implement a valve in the outlet pipe from the tower in the thermosiphon circuit. Using Aspen EDR, engineers evaluated the impact of reducing the return line diameter as well as other updates in internal and nozzle diameters. They were able to identify and implement changes that eliminated the instability.

While stopping the amine unit for a week during the COVID-19 pandemic initially seemed risky, AspenTech's Performance Engineering solutions provided company leaders confidence in their decision. The software provided rigorous and iterative simulations to help engineers understand and accurately model the thermosyphon circuit. In particular, the Aspen EDR model provided guidance the team needed to make informed decisions and implement these modifications in the plant (Figures 3 and 4).
